Summary of Creek Survey/

St. Joseph Creek, Downers Grove, Illinois

TECHNICAL MEMORANDUM

Subject: Summary of Fieldwork Activities
Creek Walk/Creek Survey
Downers Grove, Illinois

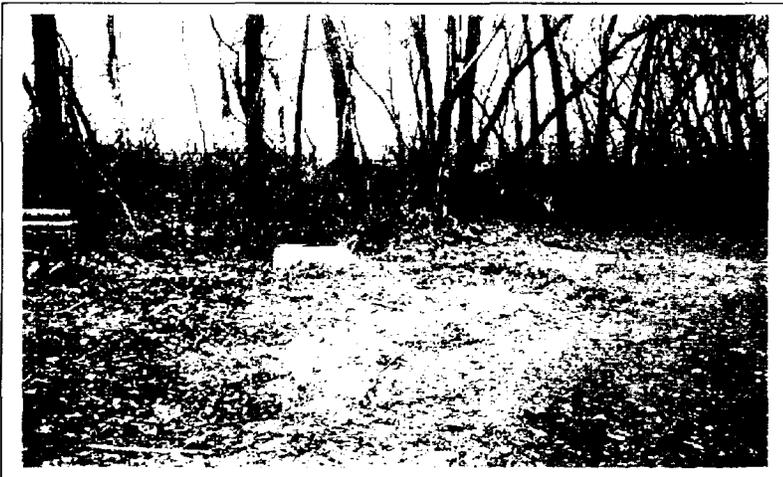
Location/Photo: 11 2-12

Description: Manhole, approximately 50' east of outfall in Photo #6.

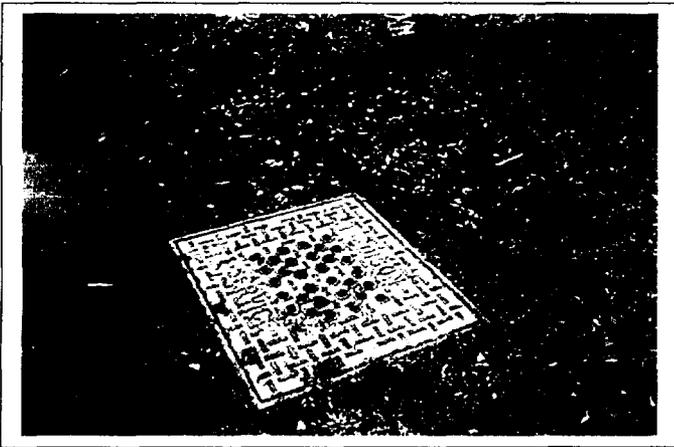
Location: Downers Grove/Lisle
Direction: NW
Date: 12/4/01
Location/Photo: 16 2-21
Photo By: S. Nataraj
Description: Manhole. no apparent outfall pipe to creek.

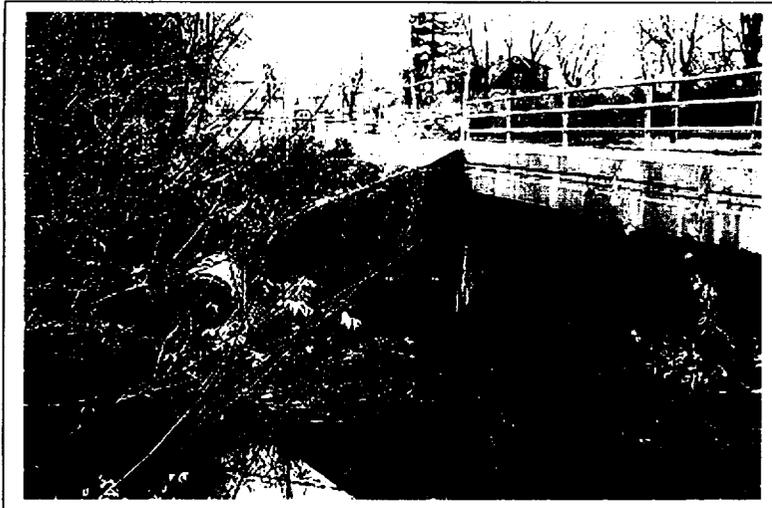
Location:	Downers Grove/Lisle
Direction:	E
Date:	12/4/01
Location/Photo:	25 4-26
Photo By:	D. McGowan
Description:	Source of stream in Photo #24

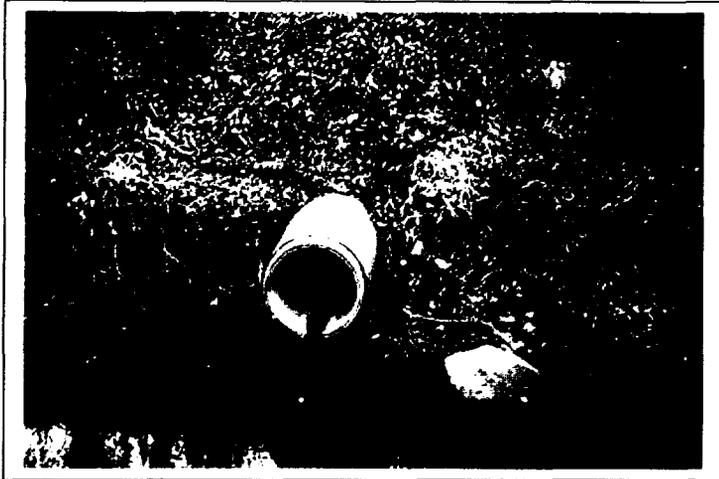
Location:	Downers Grove/Lisle
Direction:	N
Date:	12/4/01
Location/Photo:	27 1-5
Photo By:	D. McGowan
Description:	Outfall pipes and spillway from Sanitary District.

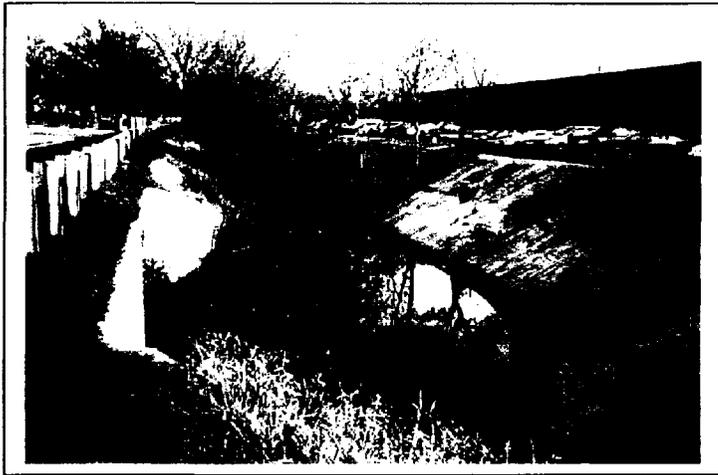
Location:	Downers Grove/Lisle
Direction:	SE
Date:	12/4/01
Location/Photo:	44 3-1
Photo By:	S. Nataraj
Description:	Bridge just east of I-355.

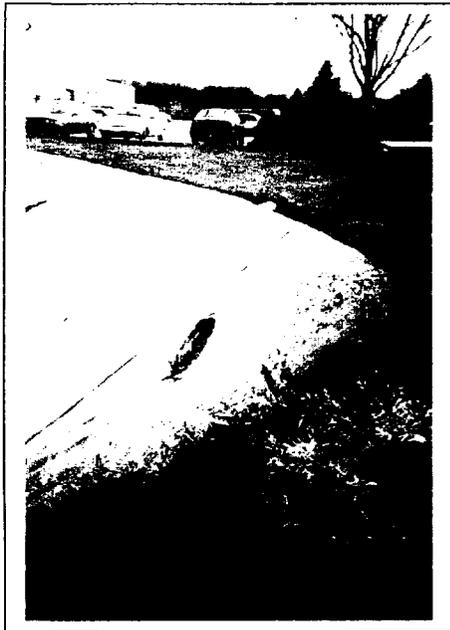
Location/Photo: 45 6-2

Description: Looking east from Curtiss St. bridge (left). Arrow Gear Inc. on south side of creek (upper-right).

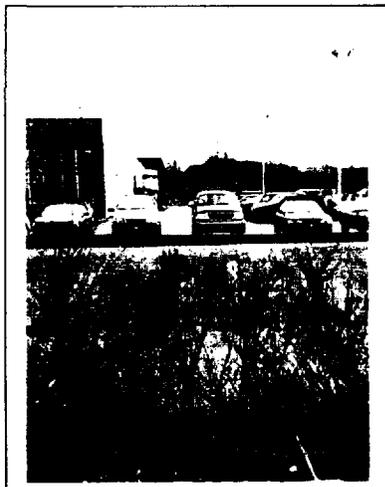
Location/Photo: 46 4-22

Description: Outfall pipe from concrete reinforced south bank. Arrow Gear Inc. in background.

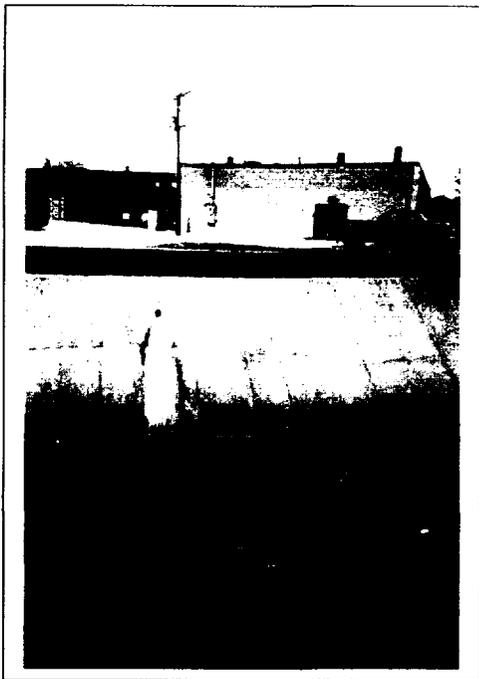
Location: Downers Grove/Lisle
Direction: N
Date: 12/4/01
Location/Photo: 59 4-16
Photo By: D. McGowan
Description: Outfall pipe in concrete reinforced north bank, Julian Service Industries Inc. in background.

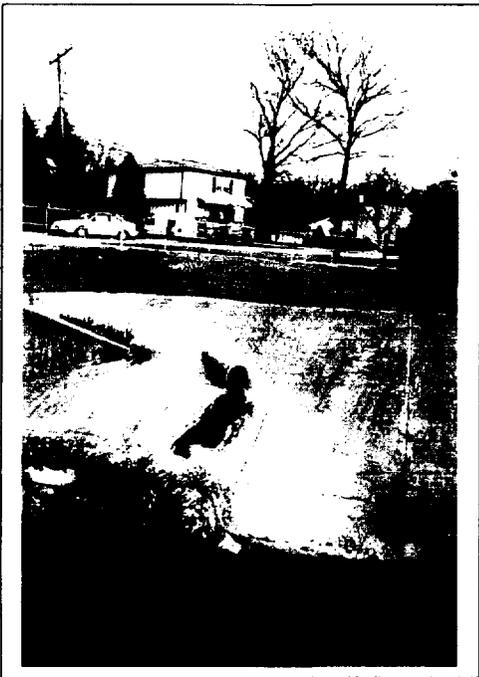
Description: Outfall pipe in concrete reinforced north bank. Delta Industries Inc. in background.

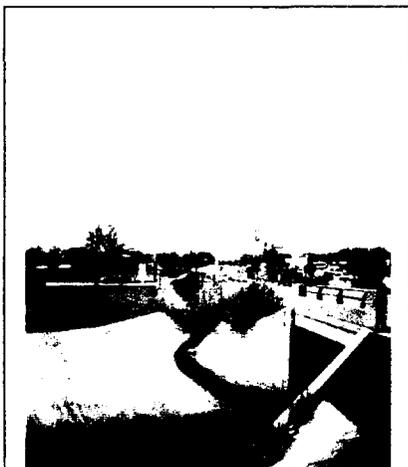
Location/Photo: 61 6-13

Description: Outfall pipe from concrete reinforced south bank. Belmont Ave. in background.

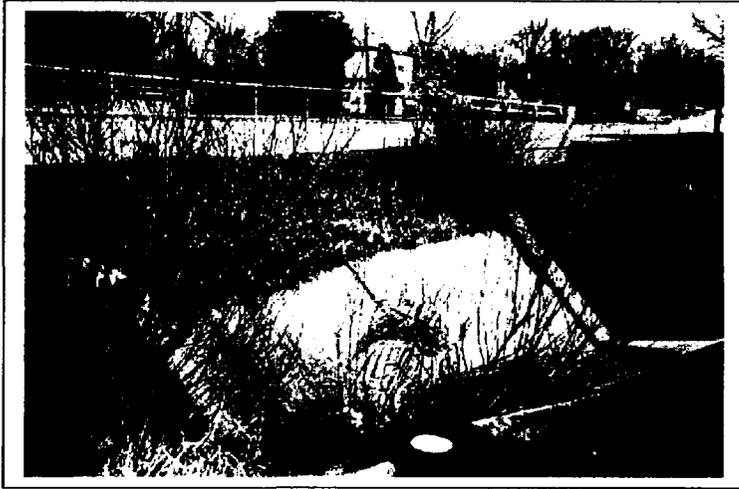
Location/Photo: 62 4-12

Description: Belmont Ave. (right) drainage culvert connection.

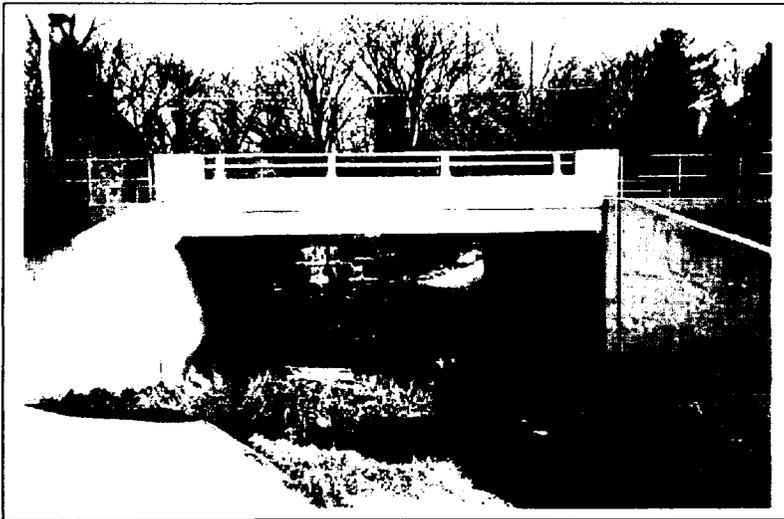
Location:	Downers Grove/Lisle
Direction:	SE
Date:	12/4/01
Location/Photo:	63 6-15
Photo By:	S. Nataraj
Description:	Outfall pipe from Belmont Ave. and manhole along side drainage culvert.
